Executive Summary
Stormwater System Assessment and Capital Improvement Program
With
Town-Wide Ranking of Recommended Alternatives

August 2017

RE: Stormwater System Assessment and Capital Improvement Program
Executive Summary with Town-Wide Ranking of Recommended Alternatives and
Individual Basin Documentation

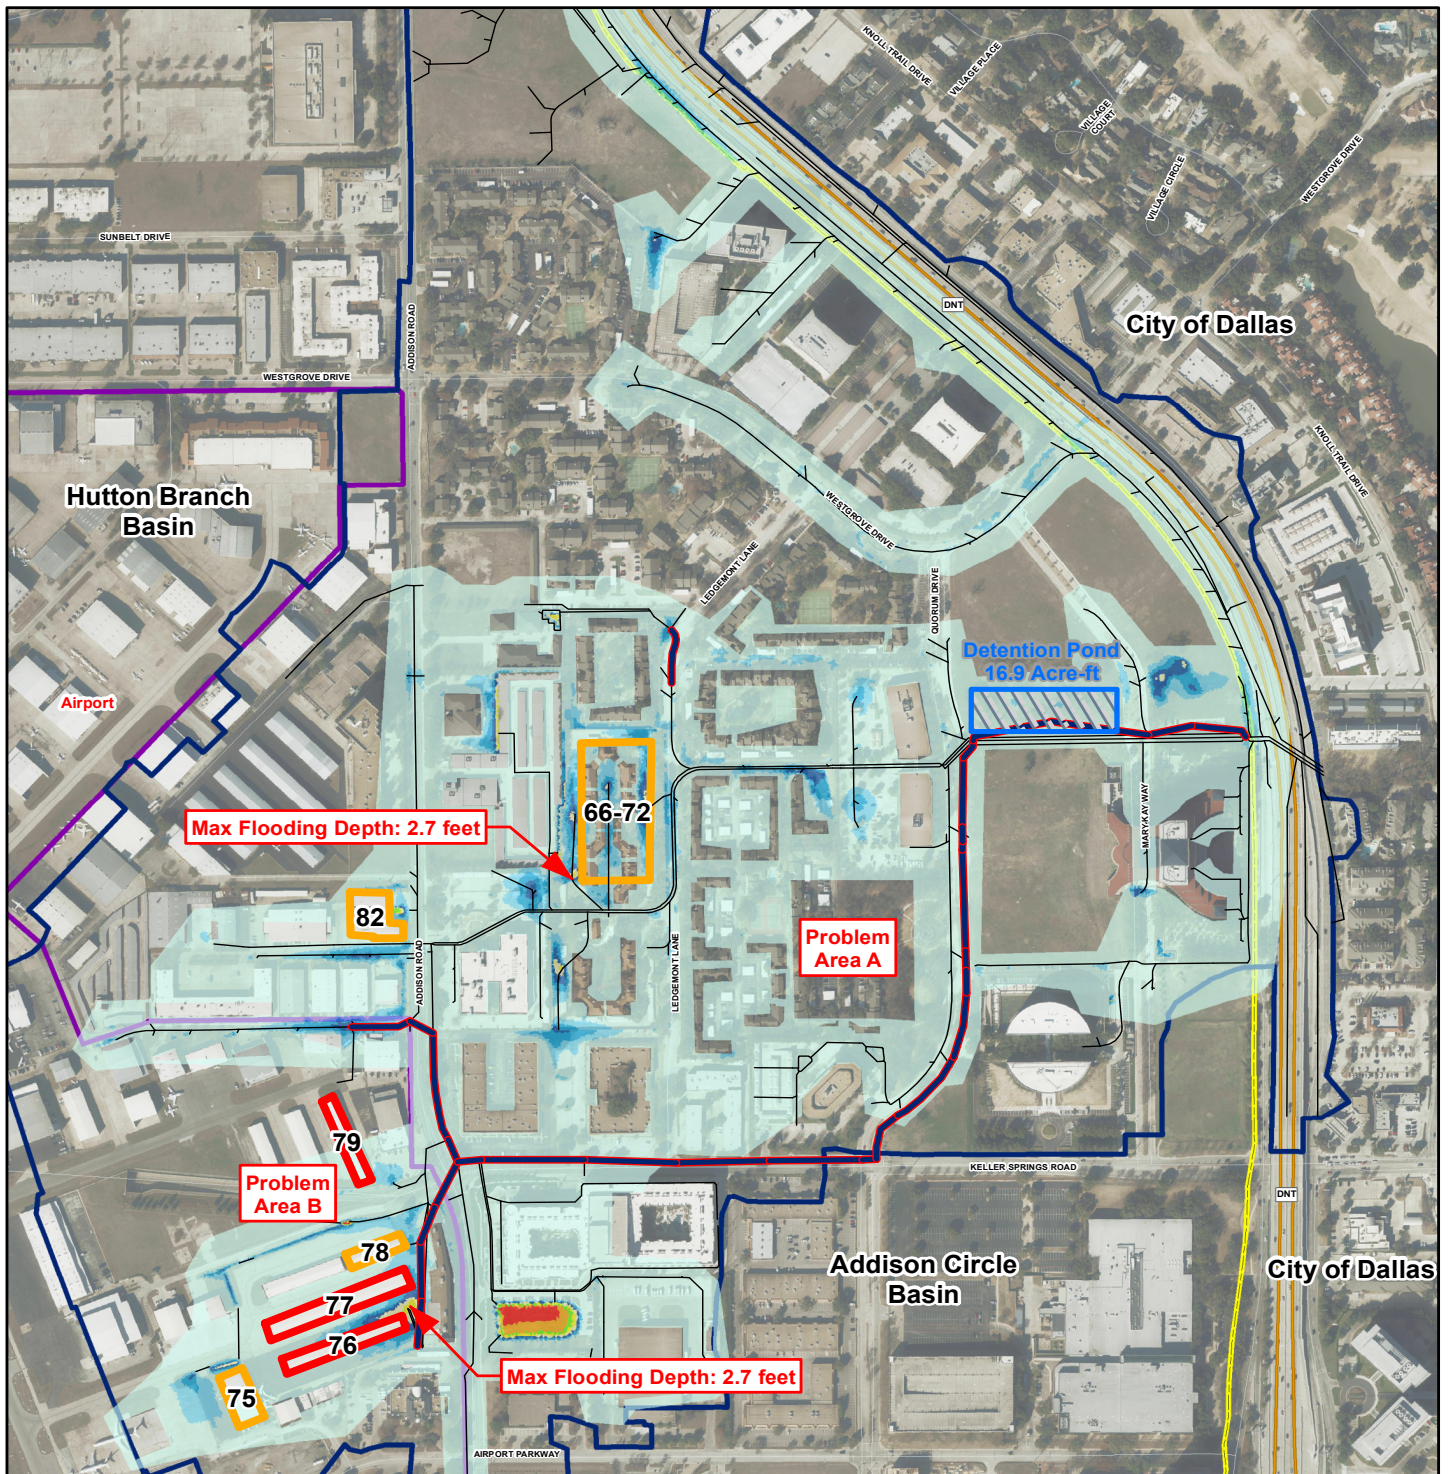
- Problem Area A – Between Addison Road and the Dallas North Tollway: To the east of the airport, the existing underground storm system is inadequate and stormwaters will pond to depths of up to 2.7 feet for the 100-year storm event in several commercial and apartment areas between Addison and Quorum Roads. Stormwater overflows (100-year flood event) will spill into the Mary Kay campus, combine with runoff generated in the campus, and collect in low areas with depths of up to 2.1 feet. Onsite first floor surveys of potentially affected structures reveal none of the structures would experience flooding as a result of a 100-year storm event.

- Problem Area B - Addison Airport: Within the Airport between Jimmy Doolittle Drive and Airport Parkway, drainage systems are inadequate and large storms will cause ponding of up to 2.7 feet deep for the 100-year storm event. Just to the north, other Airport areas within this basin are impacted by stormwater flooding to a lesser degree (up to 1.9 feet of ponding). Onsite first floor surveys of potentially affected structures reveal that 3 hangars would experience flooding as a result of a 100-year storm event.

Structures Affected		Structures Potentially Affected	
Number	Address	Number	Address
76	OptSky Airport Hanger	66 - 72	16301 LedgeMont Ln (7 apt units)
77	Addison Airport Hanger	75	Addison Airport Hanger
79	Addison Airport Hanger	78	Addison Airport Hanger
		82	16301 Addison Rd

- Problem Area A – Between Addison Road and the Dallas North Tollway: A underground stormwater relief system running from the Airport east along Keller Springs Road, then north along Quorum Road to connect to the existing underground stormwater system that traverses through the Mary Kay campus is the recommended alternative to reduce flood risk in Problem Area A of the Keller Springs Branch Basin. The proposed drainage improvement will consist of reinforced concrete box (RCB) culverts ranging up to 8-ft by 5-ft in size. Stormwater detention is needed within the Mary Kay campus to meet Mary Kay development needs and avoid increased flooding downstream in Dallas. The estimated total project cost of the recommended mitigation measures for the drainage problems in the remaining Keller Springs Branch Basin is \$5,900,000. This includes the construction cost for the recommended above-ground stormwater detention pond within the Mary Kay Campus.

- Problem Area B – Addison Airport: The best alternative to correct flooding in this part of Addison Airport (Problem Area B) is to construct an enlargement of the existing system. The proposed storm drainage improvement will consist of reinforced concrete box (RCB) culverts ranging from 5-ft by 3-ft to 7-ft by 4-ft in size. The estimated total project cost of the recommended mitigation measure for Addison Airport drainage problems in the Keller Springs Branch Basin is \$900,000. Before these Airport drainage improvements can be constructed, the recommended drainage improvements for the remaining Keller Springs Branch Basin areas (see above) must be constructed. **Figure III-1** shows the 100-year flooded areas along with the Stormwater Master Plan recommendations for Problem Areas A and B in the Keller Springs Branch Basin.

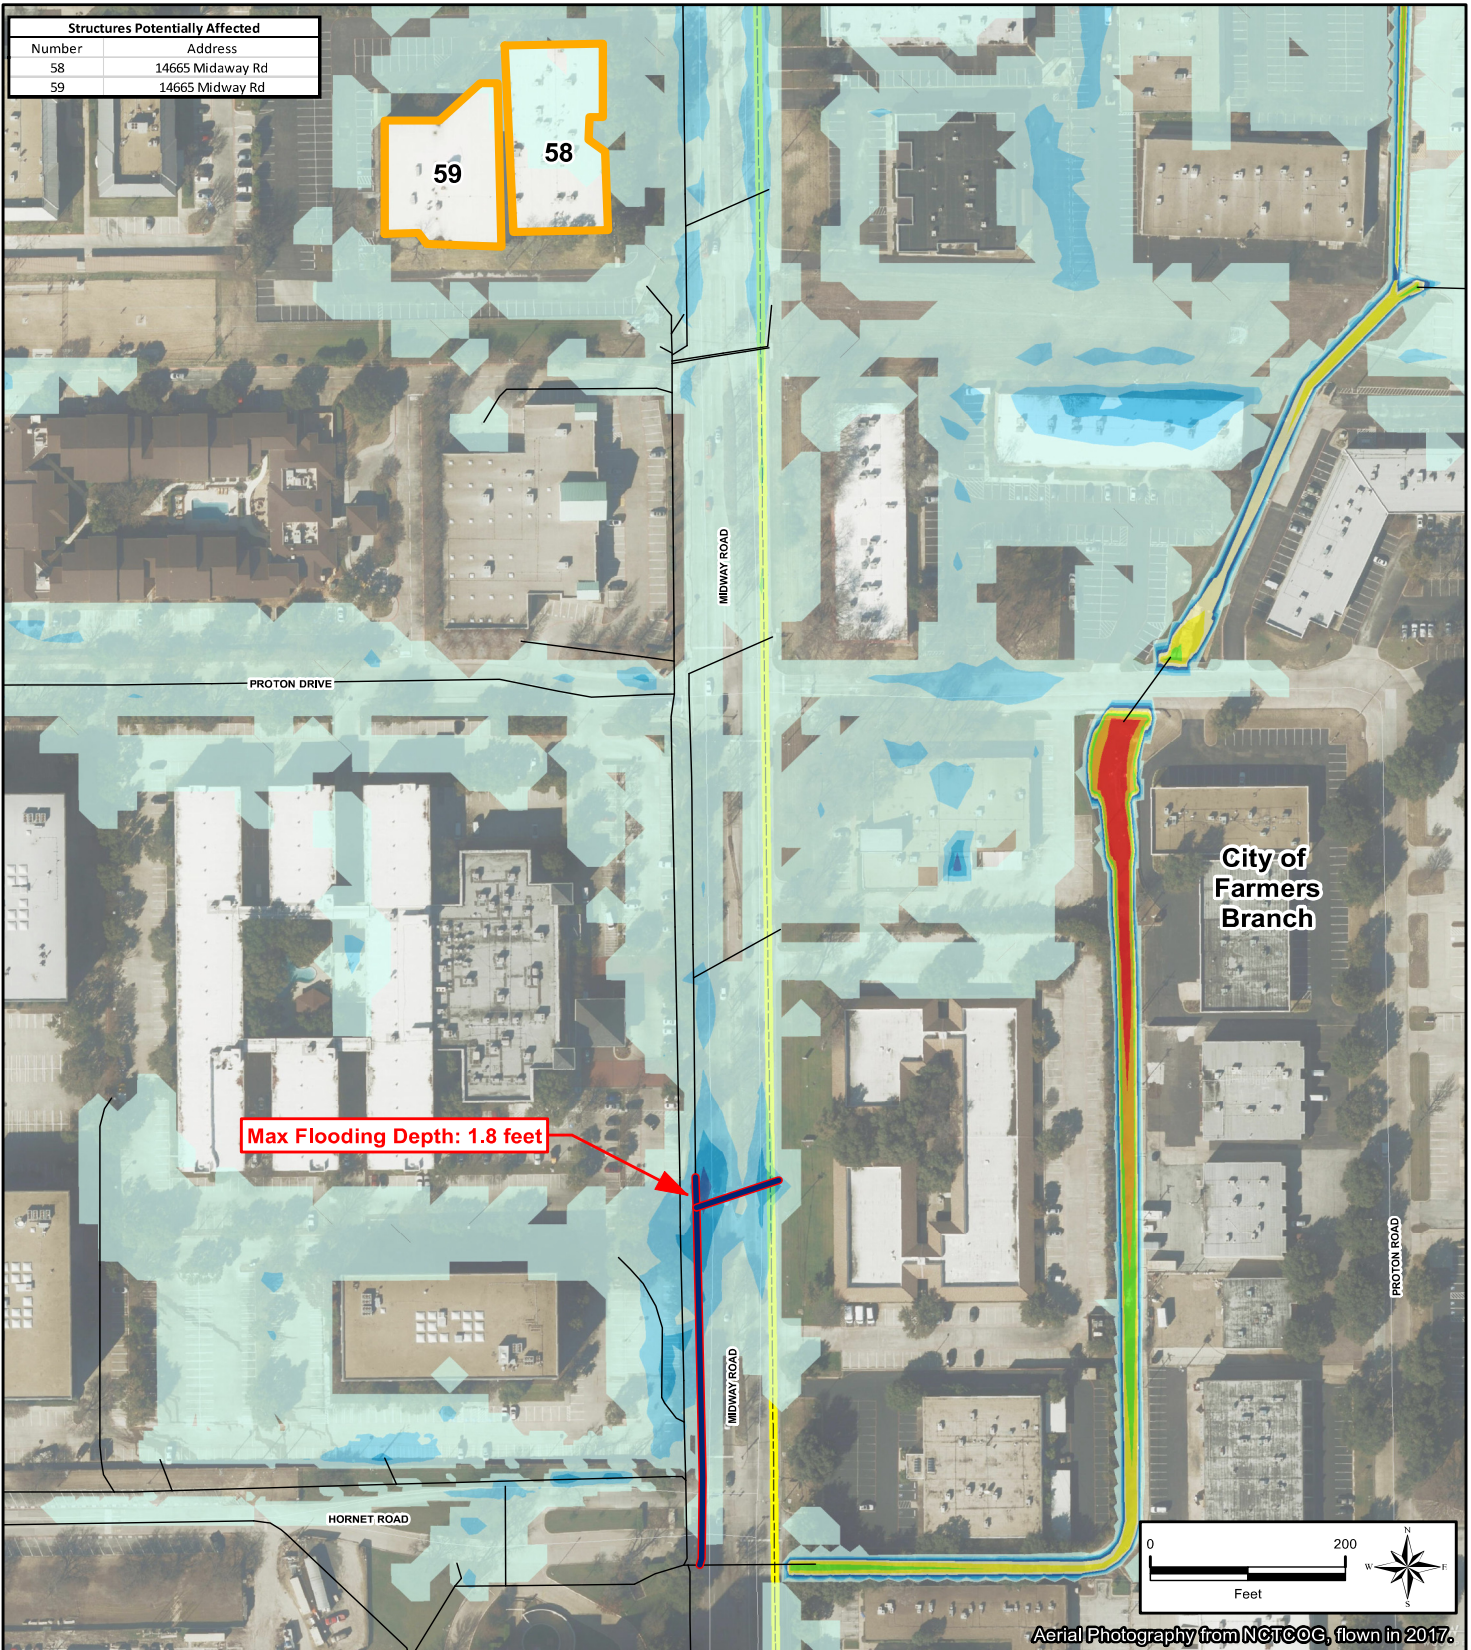
Figure III-4
Problem Area E
Recommended Plan
 (100-YR Storm Event)

- **Problem Area E – Midway Road:** This problem area is located on Midway Road near its intersection with Hornet Road. At this location, the capacity of the existing underground stormwater system is exceeded, which causes the system to surcharge. Stormwaters pond in this area to a maximum depth of 1.8 feet for the 100-year and 1.3 feet for the 10-year storm events. Detailed onsite surveys in the area result in two (2) commercial structures potentially impacted by the 100-year storm event.

Structures Potentially Affected	
Number	Address
58	14665 Midway Rd
59	14665 Midway Rd

- **Problem Area E – Midway Road:** The best alternative to correct flooding along Midway Road is to add inlets and upsize the existing system. The proposed upsized system will consist of a 36-in RCP and a 5-ft by 4-ft RCB. The estimated total project cost of the recommended mitigation measure for the Midway Road drainage problem in the Farmers Branch Basin is \$630,000. **Figure III-4** shows the flooded areas based on current conditions and the recommended drainage

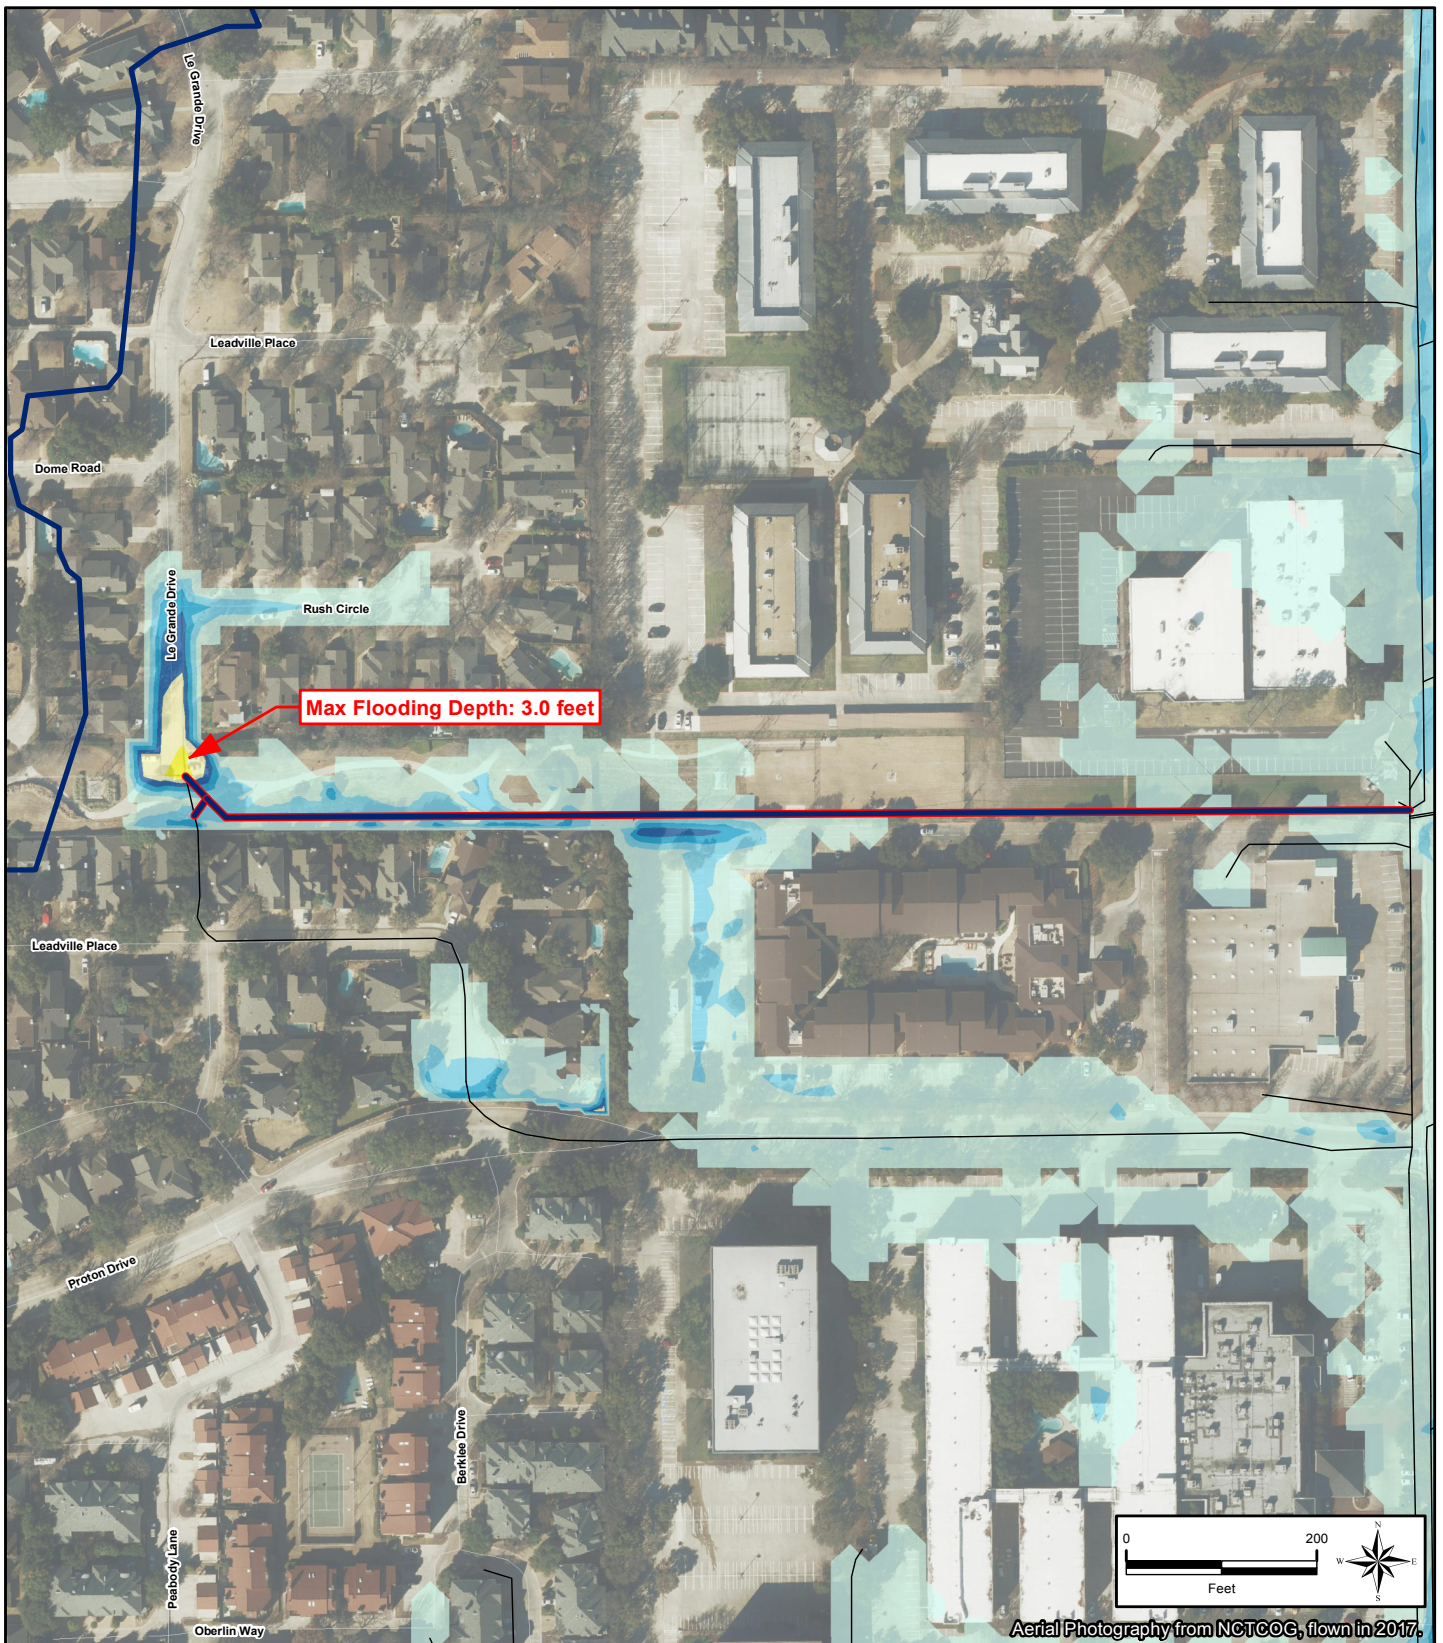
Figure III-5

- **Problem Area F – LeGrande Drive:** This problem area is located at end of the LeGrande Drive cul-de-sac. At this location, the capacity of the existing underground stormwater system is exceeded, which causes the system to surcharge. Stormwaters pond in this area to a maximum depth of 3 feet for the 100-year and 2.5 feet for the 10-year storm events. Detailed onsite surveys in the area reveal that no structures are impacted or potentially impacted by flooding at this location.

- Problem Area F – Le Grande Drive: The best alternative to correct flooding at Le Grande Drive is to add inlets and divert flow to the existing system along Midway Road. The proposed diversion will consist of a 30-in RCP. The estimated total project cost of the recommended mitigation measure for the Le Grande Drive drainage problem in the Farmers Branch Basin is \$643,000. **Figure III-5** shows the flooded areas based on current conditions along with the recommended drainage relief system for Problem Area F.

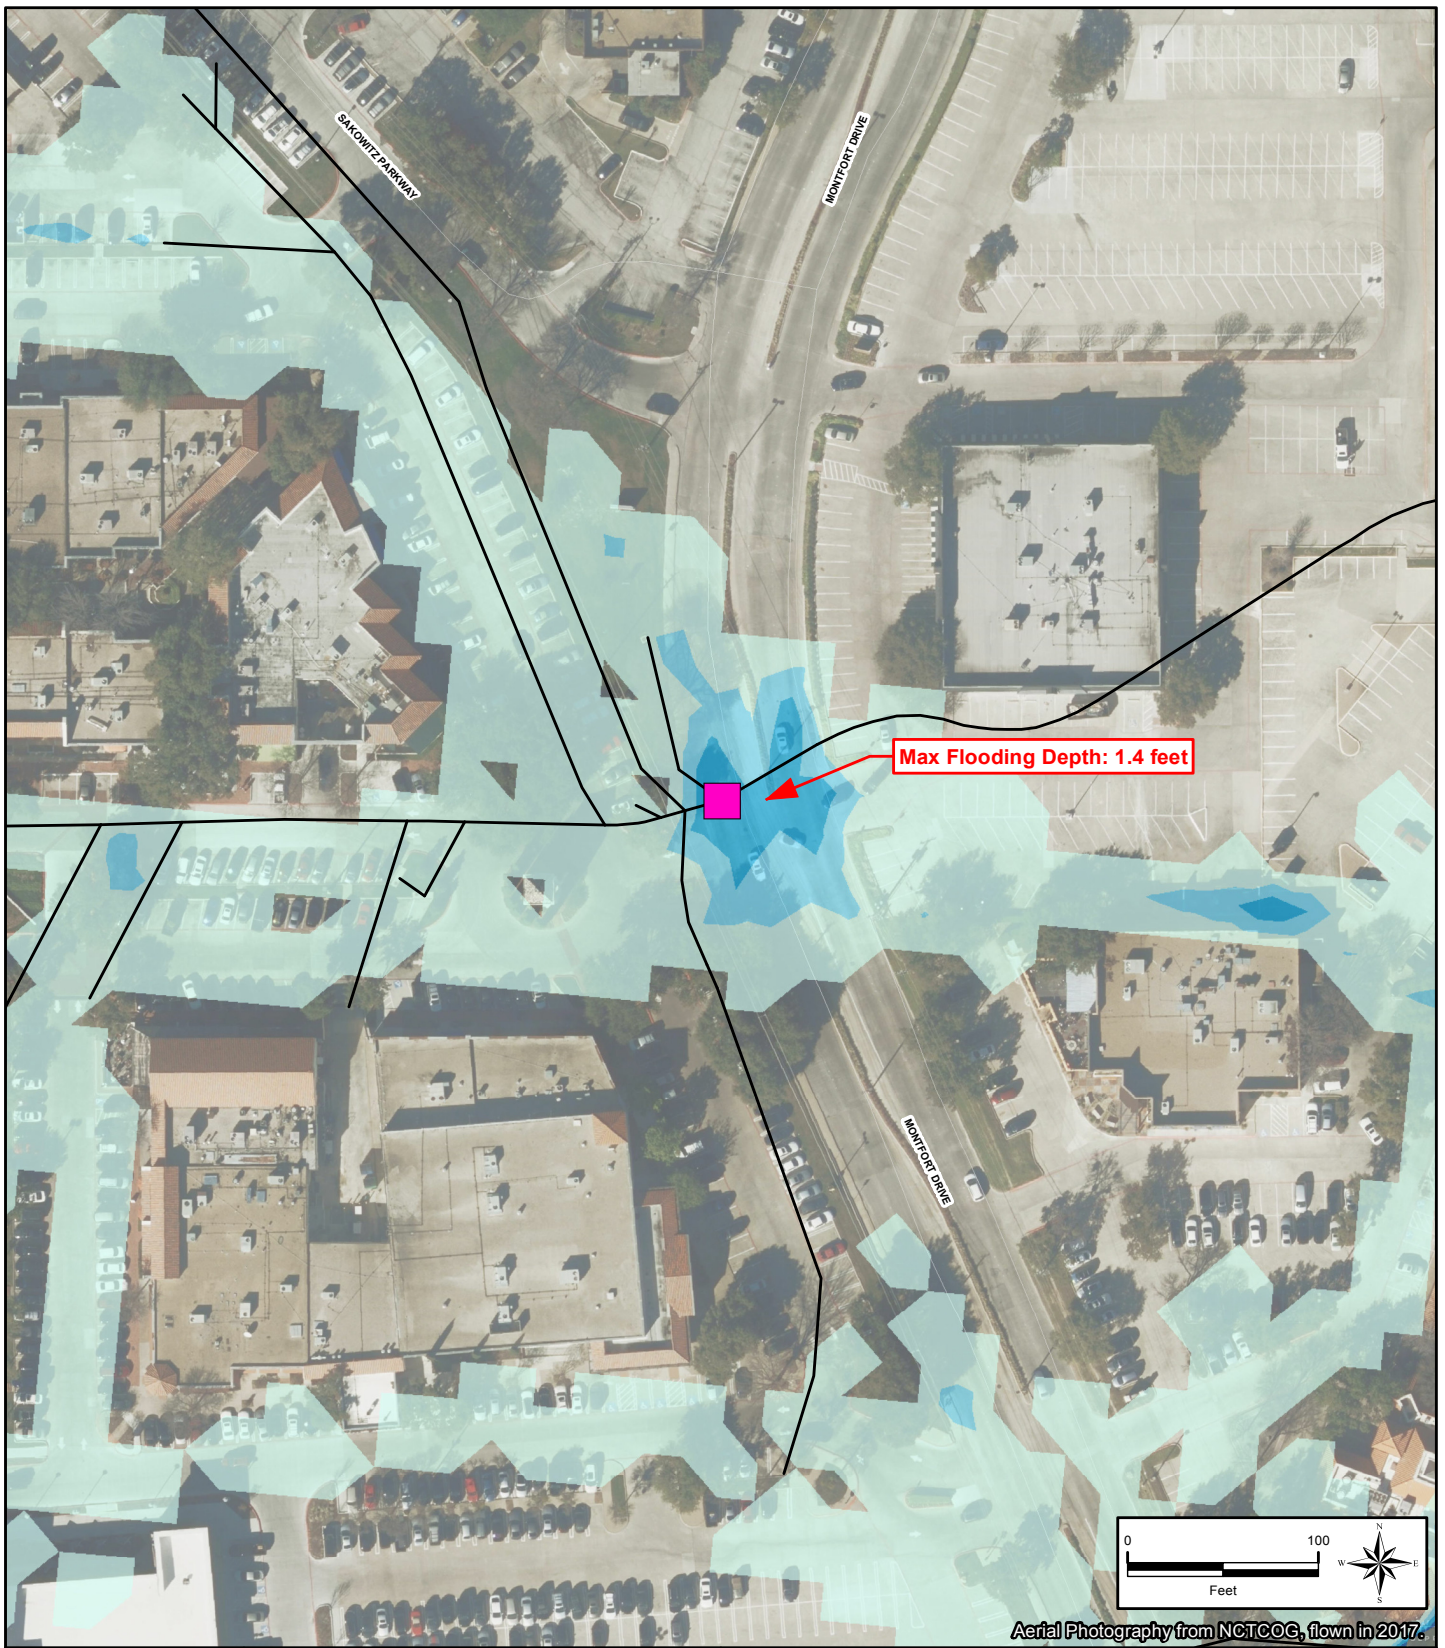
Figure III-6

- **Problem Area G – Montfort Drive:** This problem area is located along Montfort Drive near the Village on the Parkway shopping center. The existing stormwater system does not have enough inlet capacity to convey the 100-year storm event. The lack of inlet capacity causes flood depths up to 1.4 feet for the 100-year and 0.9 feet for the 10-year storm events. There are no structures impacted or potentially impacted by flooding at this location.

- Problem Area G – Montfort Drive: The best alternative to correct flooding at Montfort Drive is to add more inlets to the existing system. The proposed alternative is to add four (4) 10-foot curb inlets at the area of flooding. The estimated total project cost of the recommended mitigation measure for the Montfort Drive drainage problem in the White Rock Creek Basin is \$101,000. **Figure III-6** shows the flooded areas based on current conditions and the recommended drainage relief system for Problem Area G.

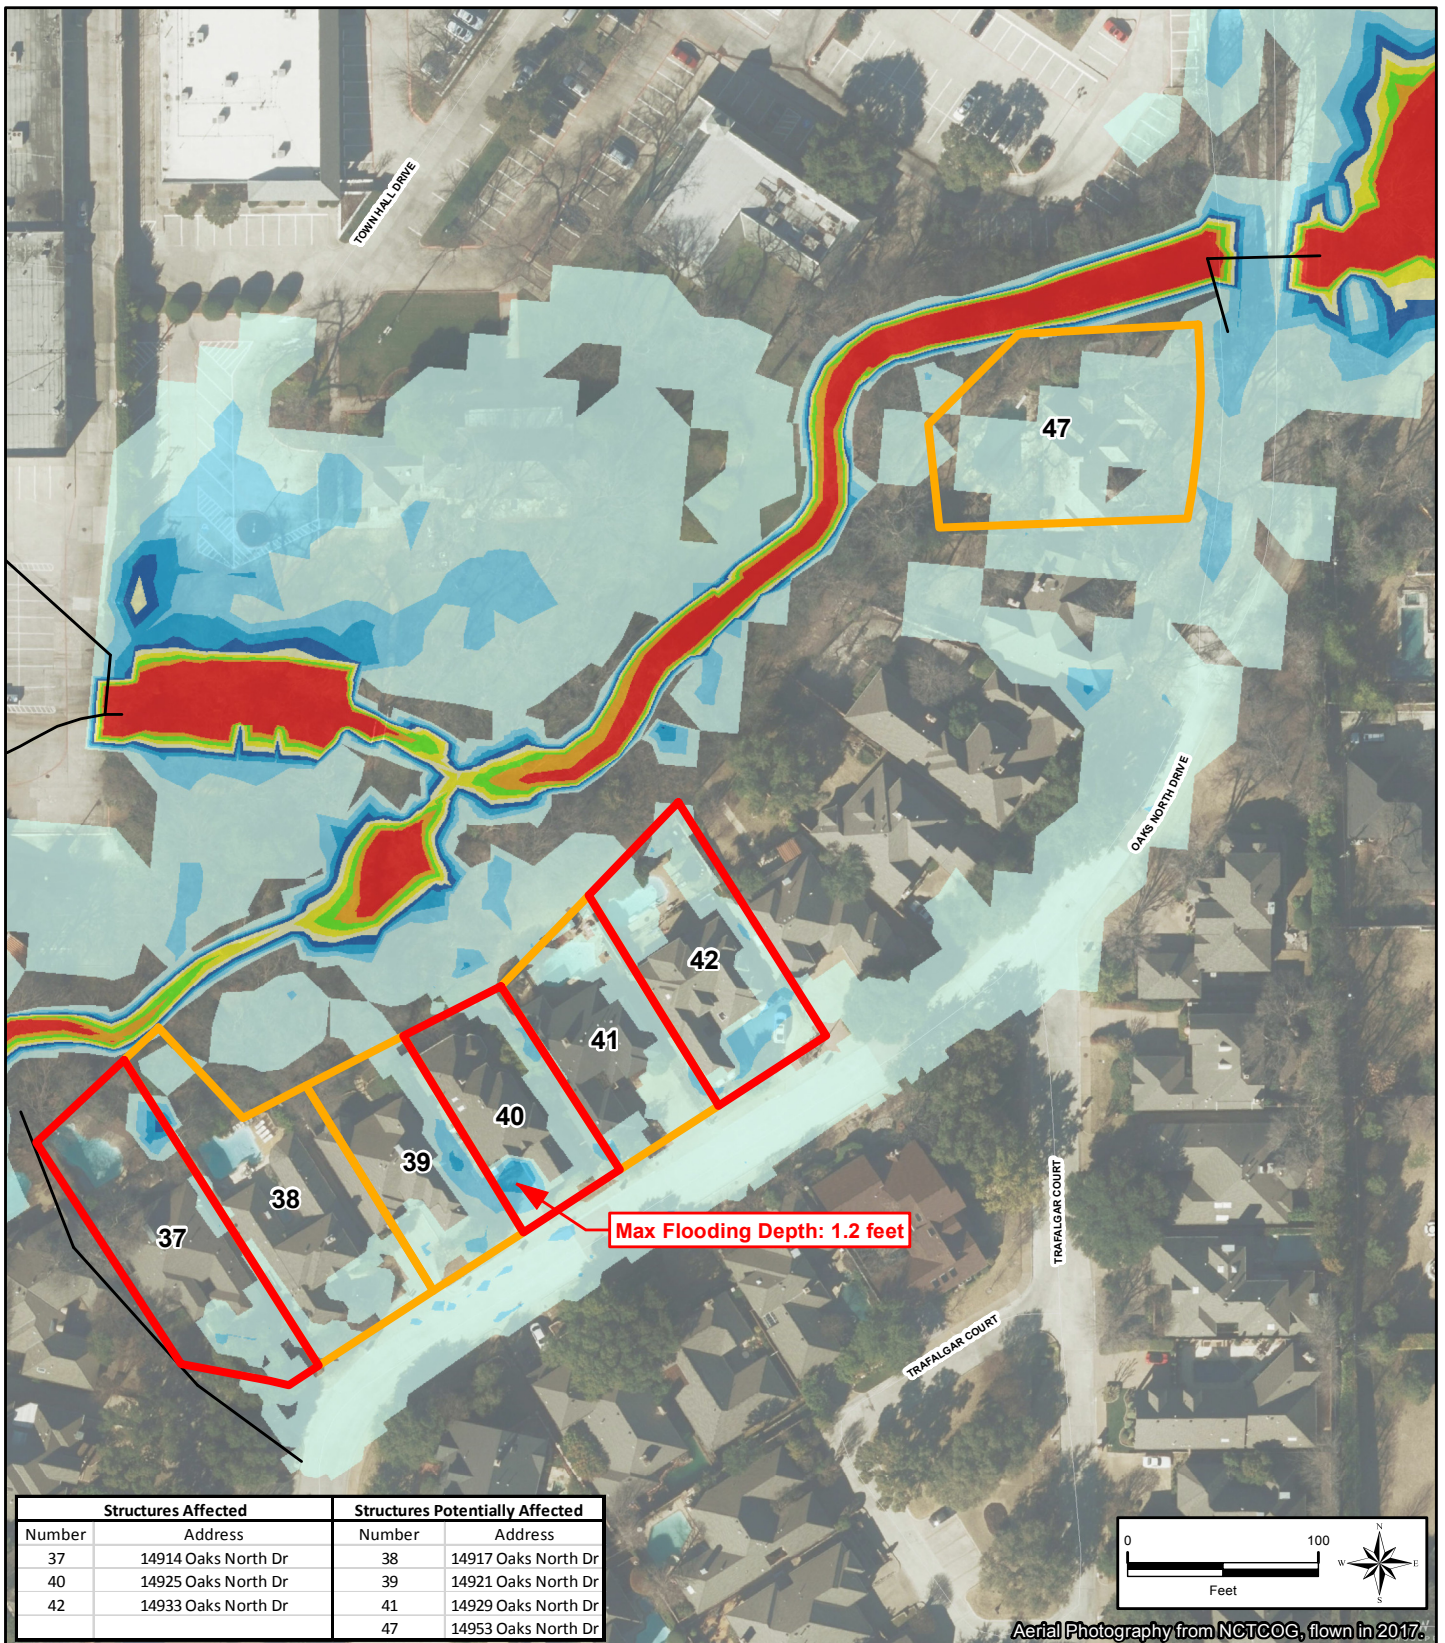
Problem Area H Recommended Plan (100-YR Storm Event)

Structures Affected		Structures Potentially Affected	
Number	Address	Number	Address
37	14914 Oaks North Dr	38	14917 Oaks North Dr
40	14925 Oaks North Dr	39	14921 Oaks North Dr
42	14933 Oaks North Dr	41	14929 Oaks North Dr
		47	14953 Oaks North Dr

- Problem Area H – Oaks North Drive: The best alternative to correct flooding along Oaks North Drive is to add more inlets to the existing system. The proposed alternative is to add two (2) 10-foot curb inlets strategically located at the bend in Oaks North Drive. The estimated total project cost of the recommended mitigation measure for the Oaks North Drive drainage problem in the White Rock Creek Basin is \$90,000. **Figure III-7** shows the flooded areas based on current conditions and the recommended drainage relief system for Problem Area H.

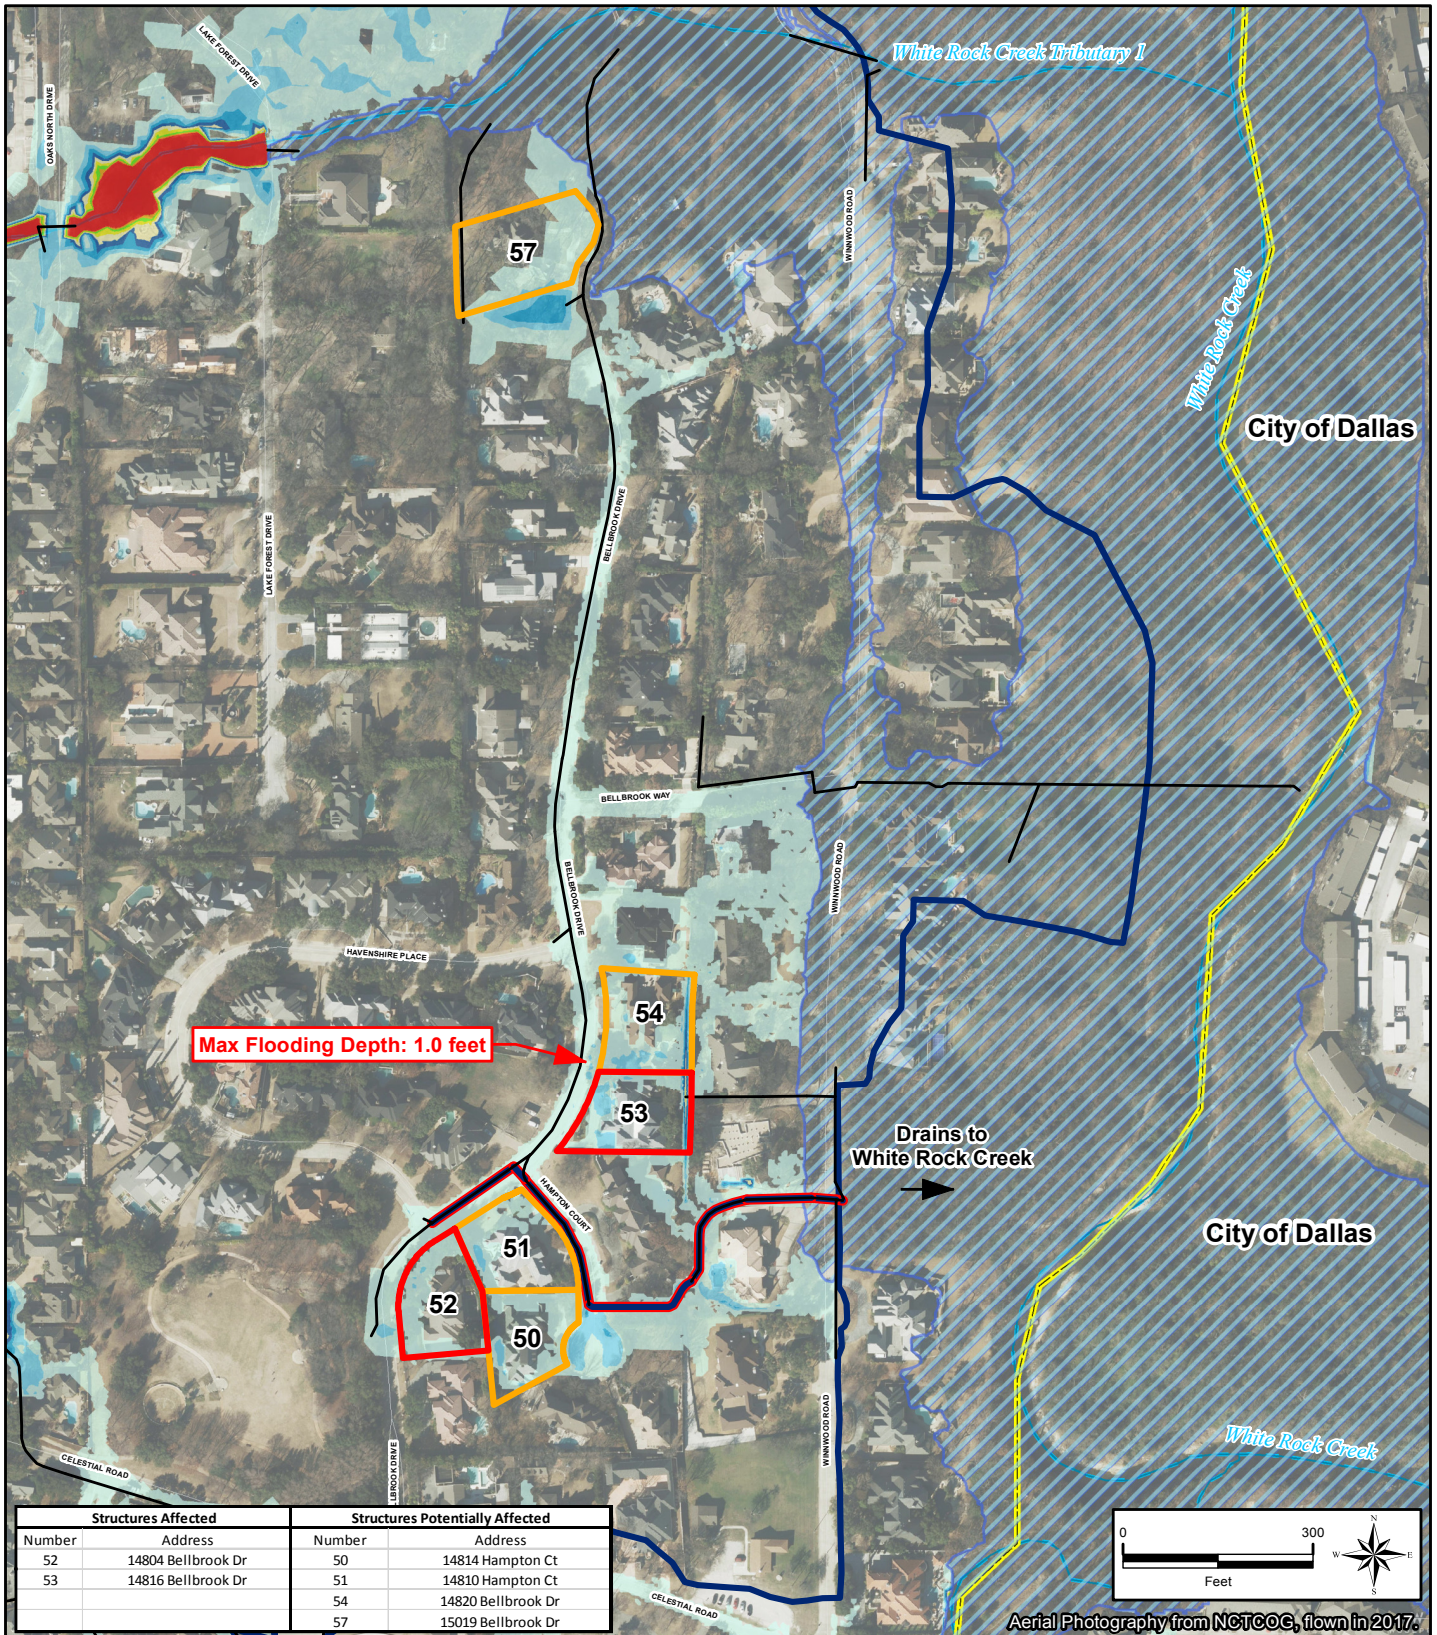
Figure III-8
Problem Area I
Recommended Plan
 (100-YR Storm Event)

Structures Affected		Structures Potentially Affected	
Number	Address	Number	Address
52	14804 Bellbrook Dr	50	14814 Hampton Ct
53	14816 Bellbrook Dr	51	14810 Hampton Ct
		54	14820 Bellbrook Dr
		57	15019 Bellbrook Dr

- Problem Area I – Bellbrook Drive: The best alternative to correct flooding along Bellbrook Drive is to upsize the existing system and create a diversion from Bellbrook Drive through Hampton Court to relieve the existing system. The proposed system will consist of reinforced concrete pipes (RCP) ranging from 30-in to 36-in in size. The estimated total project cost of the recommended mitigation measure for the Bellbrook Drive drainage problem in the White Rock Creek Basin is \$670,000. **Figure III-8** shows the flooded areas based on current conditions and the recommended drainage relief system for Problem Area I.

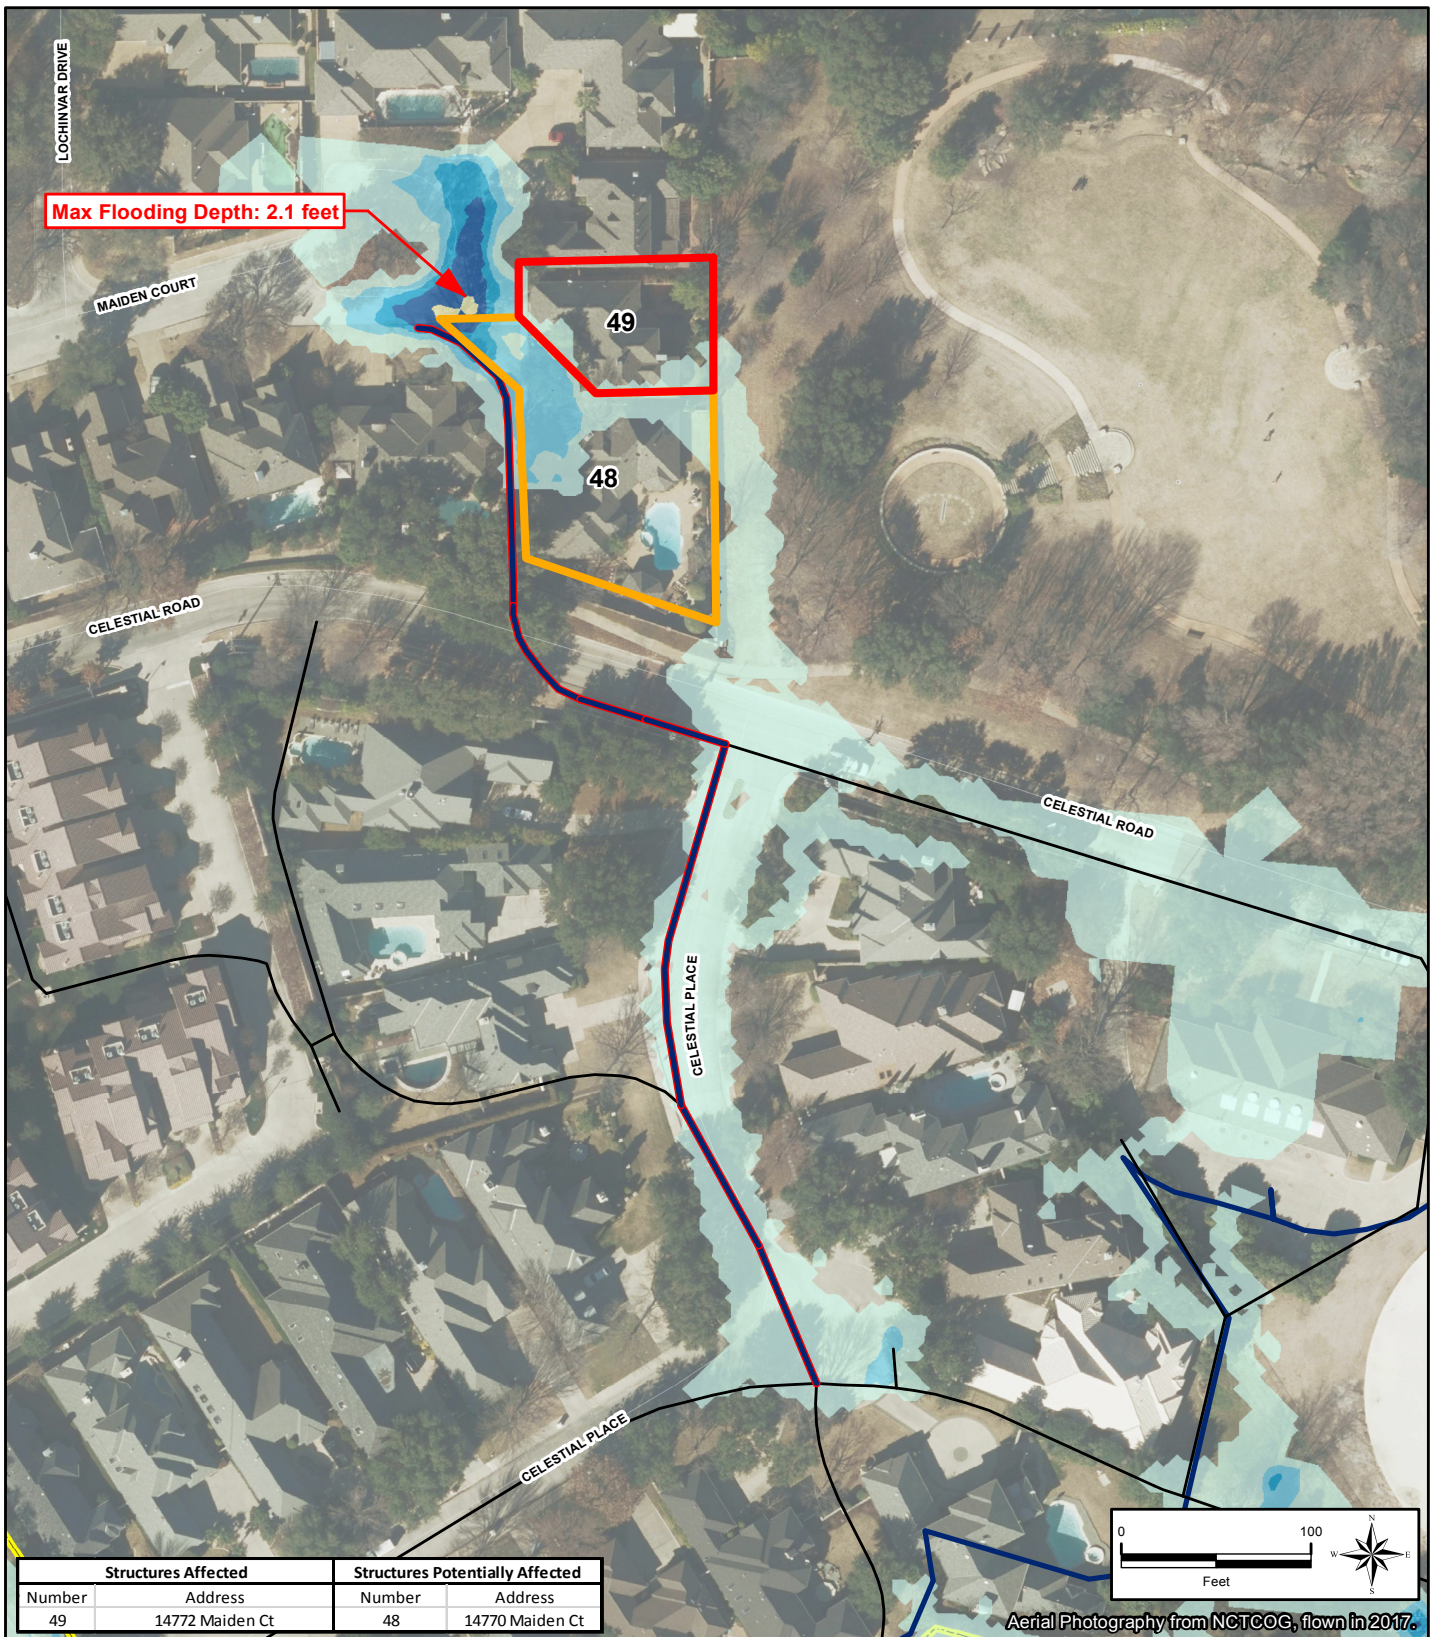
Problem Area J Recommended Plan (100-YR Storm Event)

- **Problem Area J – Maiden Court:** This problem area is located at the Maiden Court cul-de-sac. At this location, the hydraulic capacity of the existing underground stormwater system is exceeded, which causes the system to surcharge. Stormwaters pond in this area to a maximum depth of 2.1 feet for the 100-year and 1.1 feet for the 10-year storm events. The flooding (100-year storm event) impacts one (1) residential structure based on onsite surveys of floor elevations.

Structures Affected		Structures Potentially Affected	
Number	Address	Number	Address
49	14772 Maiden Ct	48	14770 Maiden Ct

- Problem Area J – Maiden Court: The best alternative to correct flooding at Maiden Court is to upsize the existing system and construct a diversion through Celestial Place to relieve the existing system. The proposed system will consist of 27-in RCP. The estimated total project cost of the recommended mitigation measure for the Maiden Court drainage problem in the White Rock Creek Basin is \$490,000. **Figure III-9** shows the flooded areas based on current conditions along with the recommended drainage relief system for Problem Area J.

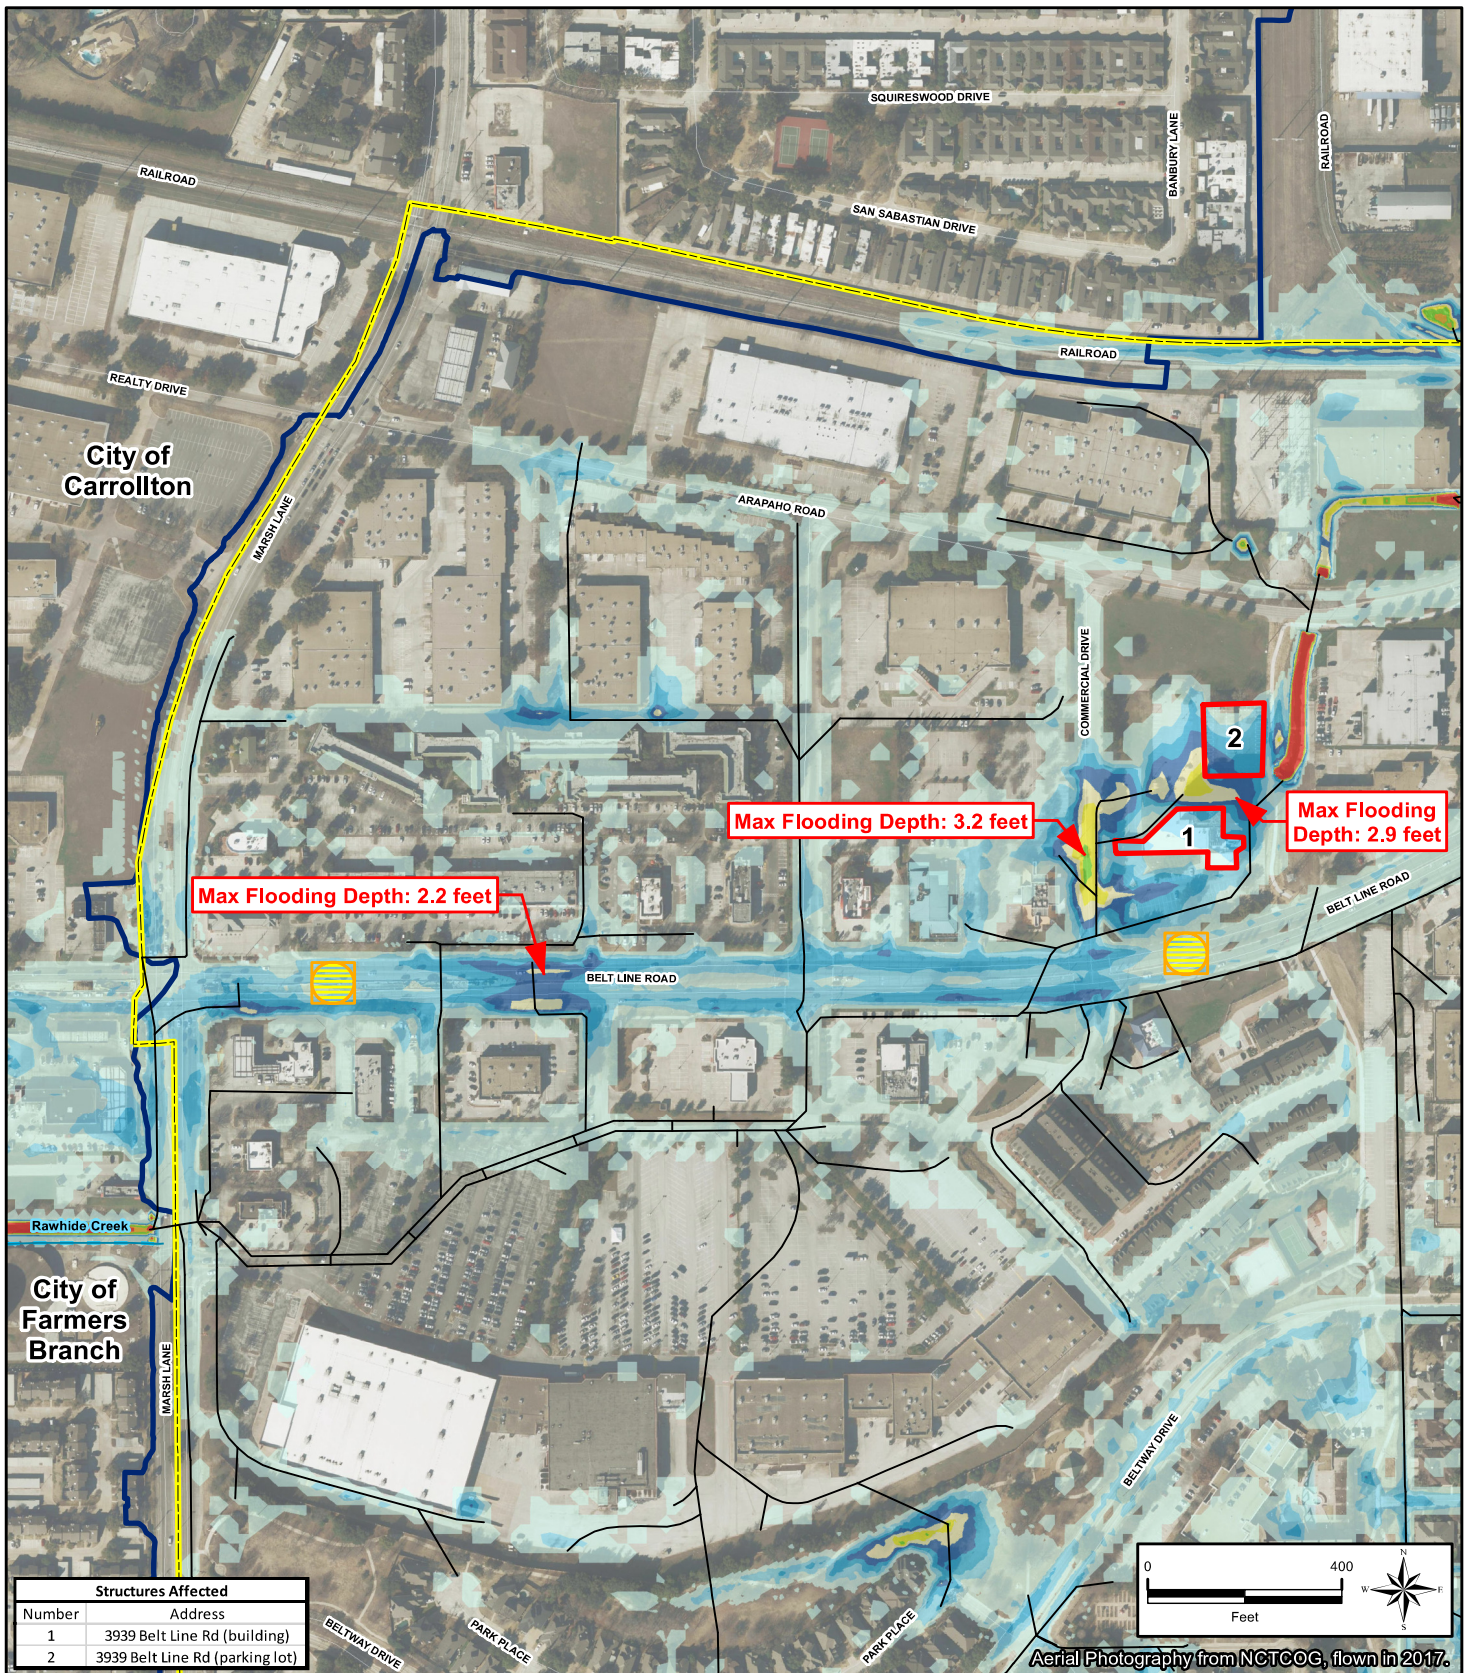
- **Problem Area K – Commercial Drive & Belt Line Road:** This problem area is located along Belt Line Road and Commercial Drive. Systems upstream (north) of Belt Line Road are inadequate for the flood flows generated in this part of the basin. This results in large stormwater spills into Commercial Drive and Belt Line Road (660 cfs of spills for the 100-year and 220 cfs for the 10-year storm events). Stormwater from an open concrete-lined channel spills to a parking lot and building located at 3939 Belt Line Road resulting in flood depths near the building of up to 1 foot for the 100-year and 0.3 feet for the 10-year. Around the parking lot the flood depths are 2.9 feet for the 100-year and 2.3 feet for the 10-year. The stormwater spill continues to Commercial Drive (with a maximum depth of 3.2 feet for the 100-year and 2 feet for the 10-year) and to Belt Line Road (with a maximum depth of 2.2 feet for the 100-year and 1.2 feet for the 10-year). Predicted 100-year flood event flooded structures include one (1) commercial building and one (1) parking structure. However, flooding is limited to the parking structure for the 10-year storm event. This information was verified by detailed onsite surveys.

Structures Affected	
Number	Address
1	3939 Belt Line Rd (building)
2	3939 Belt Line Rd (parking lot)

- Problem Area K – Commercial Drive & Belt Line Road: Several structural drainage relief alternatives were developed for Problem Area K. Costs for the various structural solutions were determined. The costs were found to be very high in light of the expected damages. Therefore, the recommended flood risk mitigation measure for Area K is to incorporate this area into the Town's Emergency Action Plan (EAP) for flooding events. Incorporating this area into the Automated Flood Alert System proposed for Problem Area C is also recommended. The estimated total project cost of the recommended automated flood alert system that includes this and other areas within the Town of Addison is \$650,000. **Figure III-10** shows the flooded areas based on current conditions and the recommended flood mitigation measure for Problem Area K.
