Executive Summary
Stormwater System Assessment and Capital Improvement Program
With
Town-Wide Ranking of Recommended Alternatives

August 2017

RE: Stormwater System Assessment and Capital Improvement Program
Executive Summary with Town-Wide Ranking of Recommended Alternatives and
Individual Basin Documentation

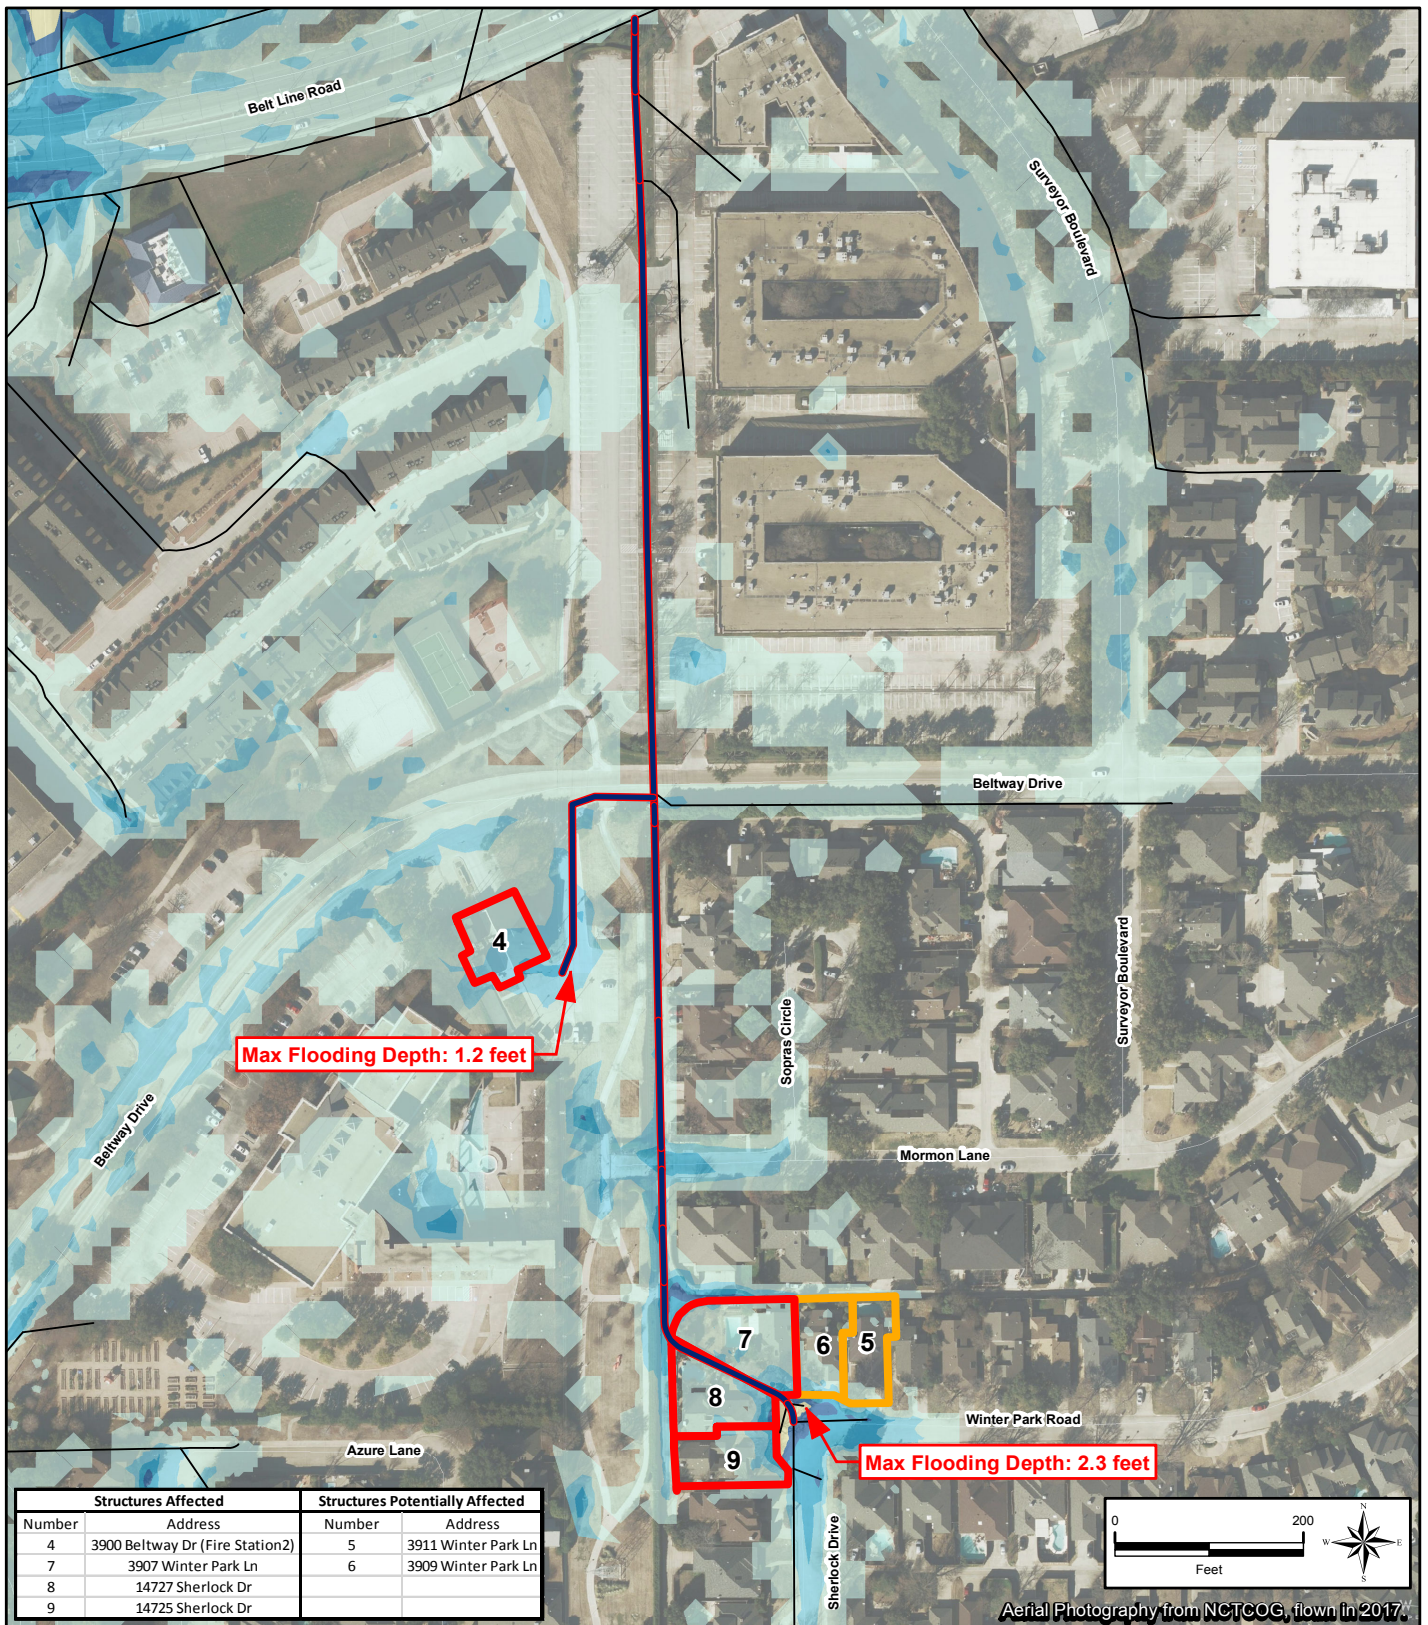
- **Problem Area L – Sherlock Drive:** This problem area is located at the intersection of Sherlock Drive and Winter Park Lane. Stormwater ponds in this area to a maximum depth of 2.3 feet for the 100-year storm event and 1.4 feet for the 10-year storm event. Upstream of this location, the capacity of the existing underground stormwater system is exceeded and it surcharges at multiple locations. Additionally, the downstream system is undersized. Flood events in recent years have caused damage to surrounding house(s). This historic flooding is one factor that makes this area a high priority candidate for storm drainage relief. Onsite first floor surveys of potentially affected structures reveal that three (3) residential structures and one (1) commercial structure in this area would experience flooding as a result of a 100-year storm event.

Structures Affected		Structures Potentially Affected	
Number	Address	Number	Address
4	3900 Beltway Dr (Fire Station2)	5	3911 Winter Park Ln
7	3907 Winter Park Ln	6	3909 Winter Park Ln
8	14727 Sherlock Dr		
9	14725 Sherlock Dr

- Problem Area L – Sherlock Drive: Several alternatives were evaluated to reduce the flood risk at the intersection of Sherlock Drive and Winter Park Lane. A letter report explaining in detail the different alternatives considered was submitted to the Town of Addison in December of 2016. The recommended system consists of a parallel storm drainage relief pipe ranging in size from 39-in to 54-in RCP. The total project cost of the recommended mitigation measure for the Sherlock problem area in the Rawhide Basin is \$1,100,000. **Figure III-11** shows the flooded areas based on current conditions and the recommended drainage relief system for Problem Area L.

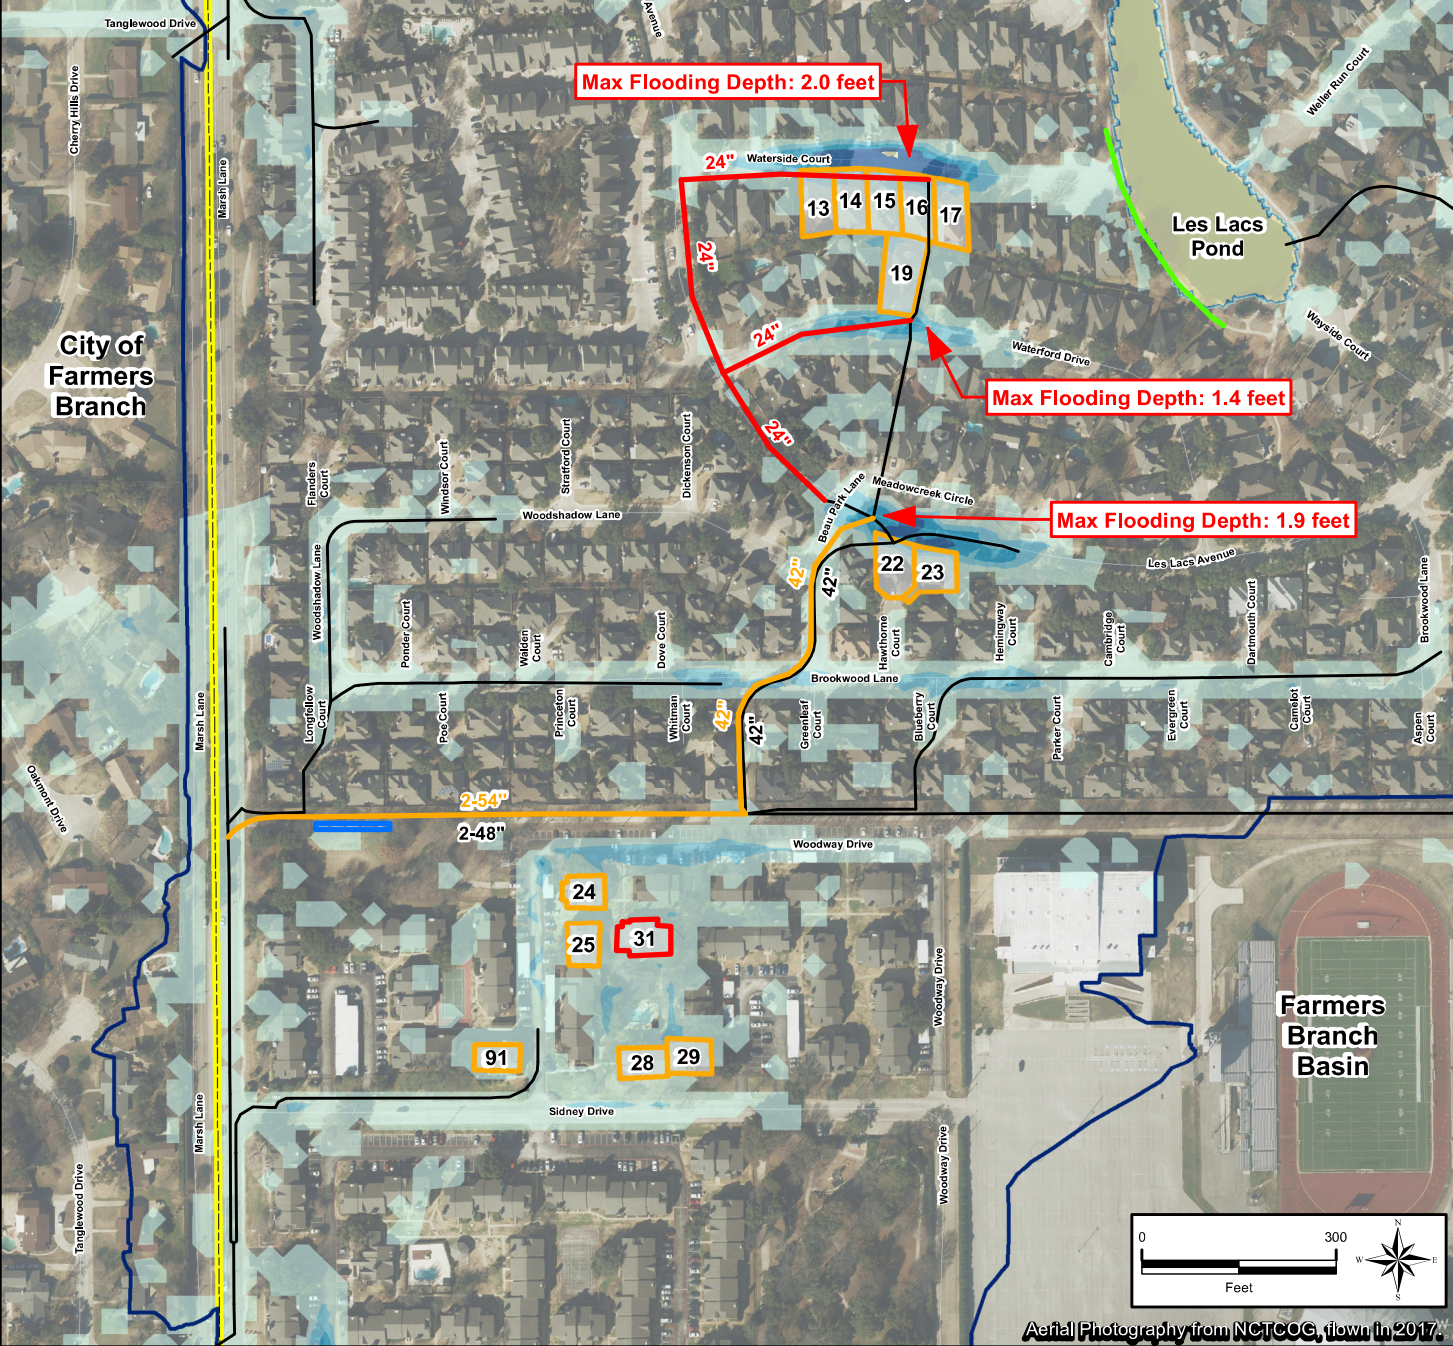
Figure III-12
Problem Area M
Recommended Plan
 (100-YR Storm Event)

Structures Affected		Structures Potentially Affected	
Number	Address	Number	Address
31	14600 Marsh Ln (1 apt. unit)	13	3776 Waterside Ct
		14	3780 Waterside Ct
		15	3784 Waterside Ct
		16	3788 Waterside Ct
		17	3792 Waterside Ct
		19	3785 Waterside Ct
		22	14616 Hawthorne Ct
		23	14612 Hawthorne Ct
		24	14600 Marsh Ln
		25	14600 Marsh Ln
		28	14600 Marsh Ln
		29	14600 Marsh Ln
		91	14600 Marsh Ln

- Problem Area M – Les Lacs Area: A underground stormwater relief system is proposed to reduce flood risk in this area. The new relief system is proposed to extend west from Waterside Court, down Les Lacs Avenue with connections to the low areas in Waterford Drive and Meadowcreek Circle. The new proposed relief then ties to the existing system at the intersection of Les Lacs Avenue and Beau Park Lane. From this point, a proposed parallel relief system continues down along Beau Park Lane then routes to the west (park area) to finally connect to the existing system at Marsh Lane. The proposed drainage improvements will consist of reinforced concrete pipe (RCP) ranging from 24-in to 54-in in size. A small underground stormwater detention facility is needed within the park at Marsh Lane to avoid increased flooding downstream in Farmers Branch. The total project cost of the recommended mitigation measures is \$1,765,000. **Figure III-12** shows the flooded areas based on current conditions along with the recommended drainage relief system for Problem Area M.

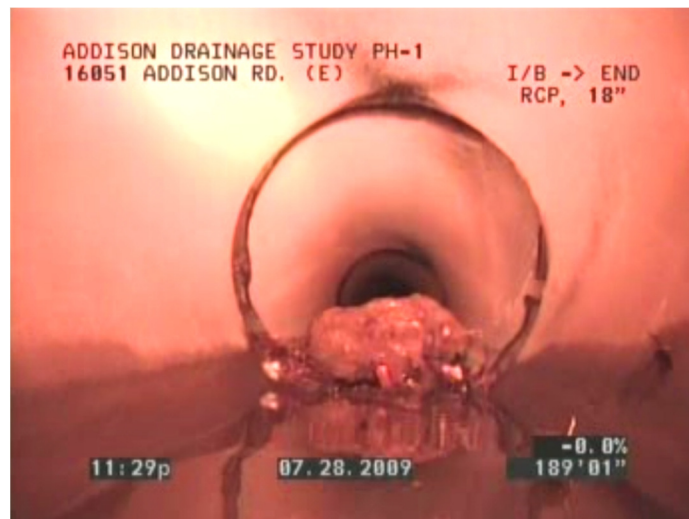
Photo IV-1: CCTV Image of Problem Area in the Keller Springs Branch Basin

- Closed-Circuit Television (CCTV): The Town of Addison should undertake a systematic program of Closed Circuit Television (CCTV) inspection of its existing underground stormwater system. CCTV inspection of existing underground storm drainage systems can be performed in order to determine condition, direction, and change in conduit size. In conjunction with the CCTV process, pipe cleaning is often performed to facilitate the video inspection activities and/or to improve system performance. Priorities for CCTV can be established based on suspected problems, age of conduit and needs for determining system size, etc. where plans are not available and access to the underground system is limited. Otherwise, systems are recommended for CCTV inspection every 10 or even 20 years. CCTV inspection of underground stormwater system just east of the Airport in Addison was performed in 2009. **Photo IV-1** shows an image of one problem area from the CCTV footage.

CCTV inspection is recommended for the drainage system in Addison to identify needed maintenance and repairs that may affect the capacity of the underground stormwater system. At this time, there have been no reports of severe problem areas. Therefore, the inspections should be conducted in phases. Please refer to the individual basin reports for CCTV recommendation.
